# Navajo Abandoned Uranium Mine Site Screen Report

**Bibo Trespass AUM Site**

**Navajo AUM Eastern Region**

**May 2009**

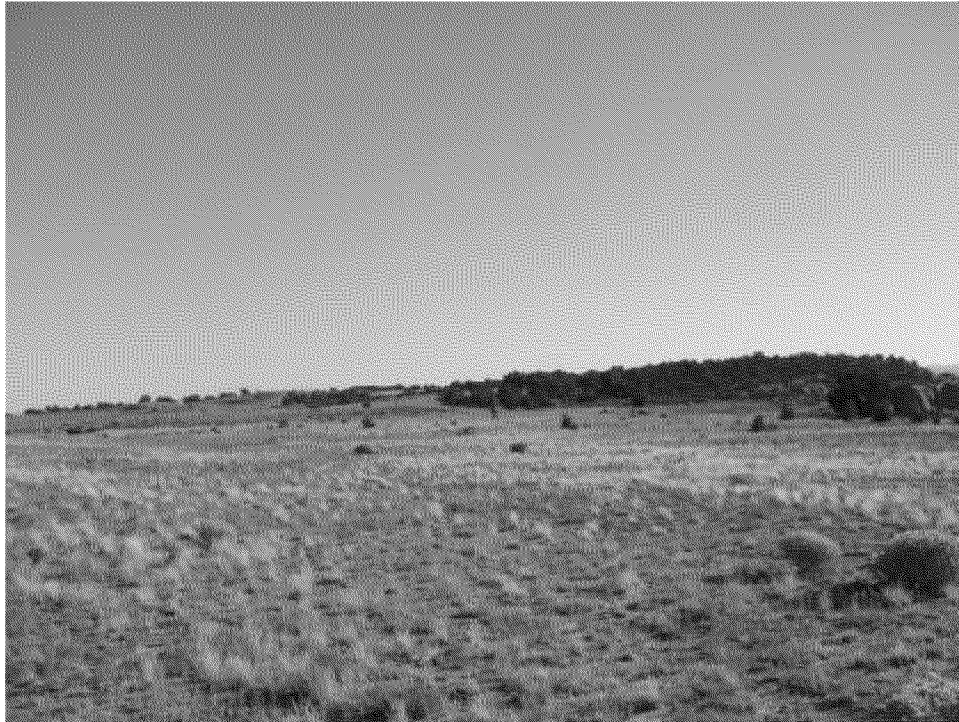
Reclamation status of the mine site is currently unknown. The mine appears to have been reclaimed by dirt covering waste piles. Signs were posted warning of underground radiological hazards. The signs were faded and nearly illegible. No adits or other mine features were observed during the site visit.

Photo 1. Bibo Trespass mine site, towards the south

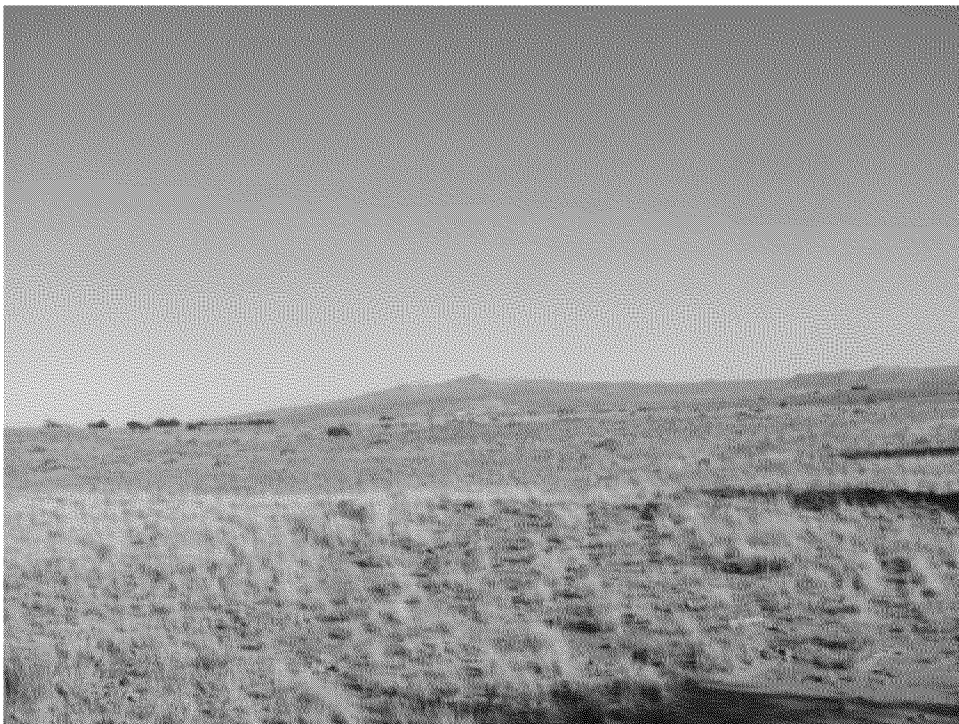
Photo 2. Bibo Trespass mine site, towards the east

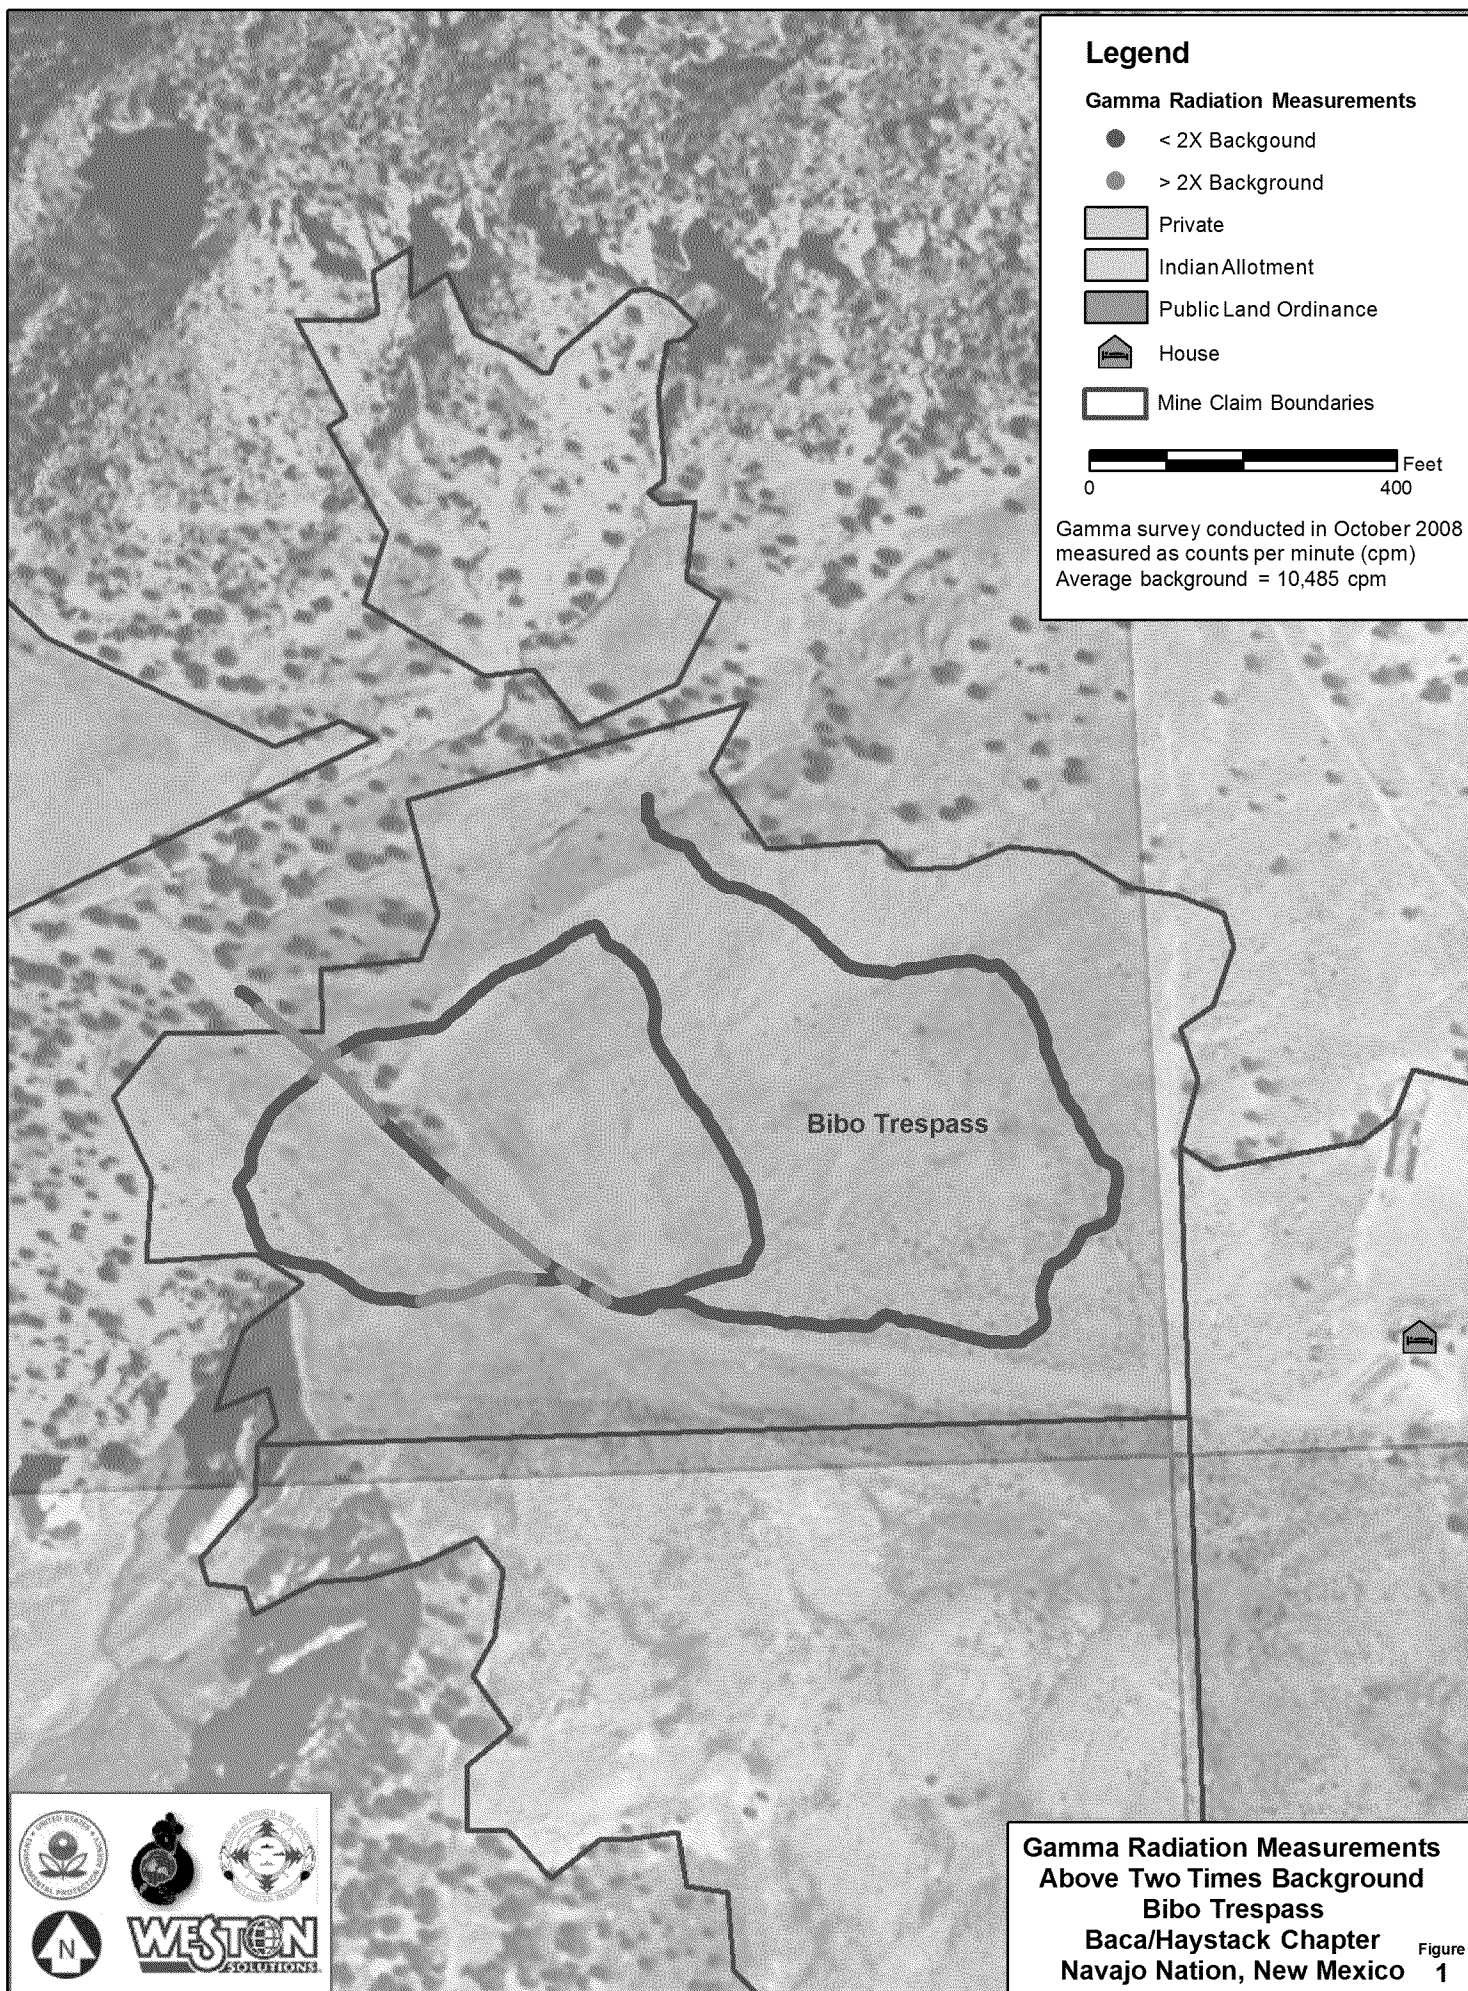
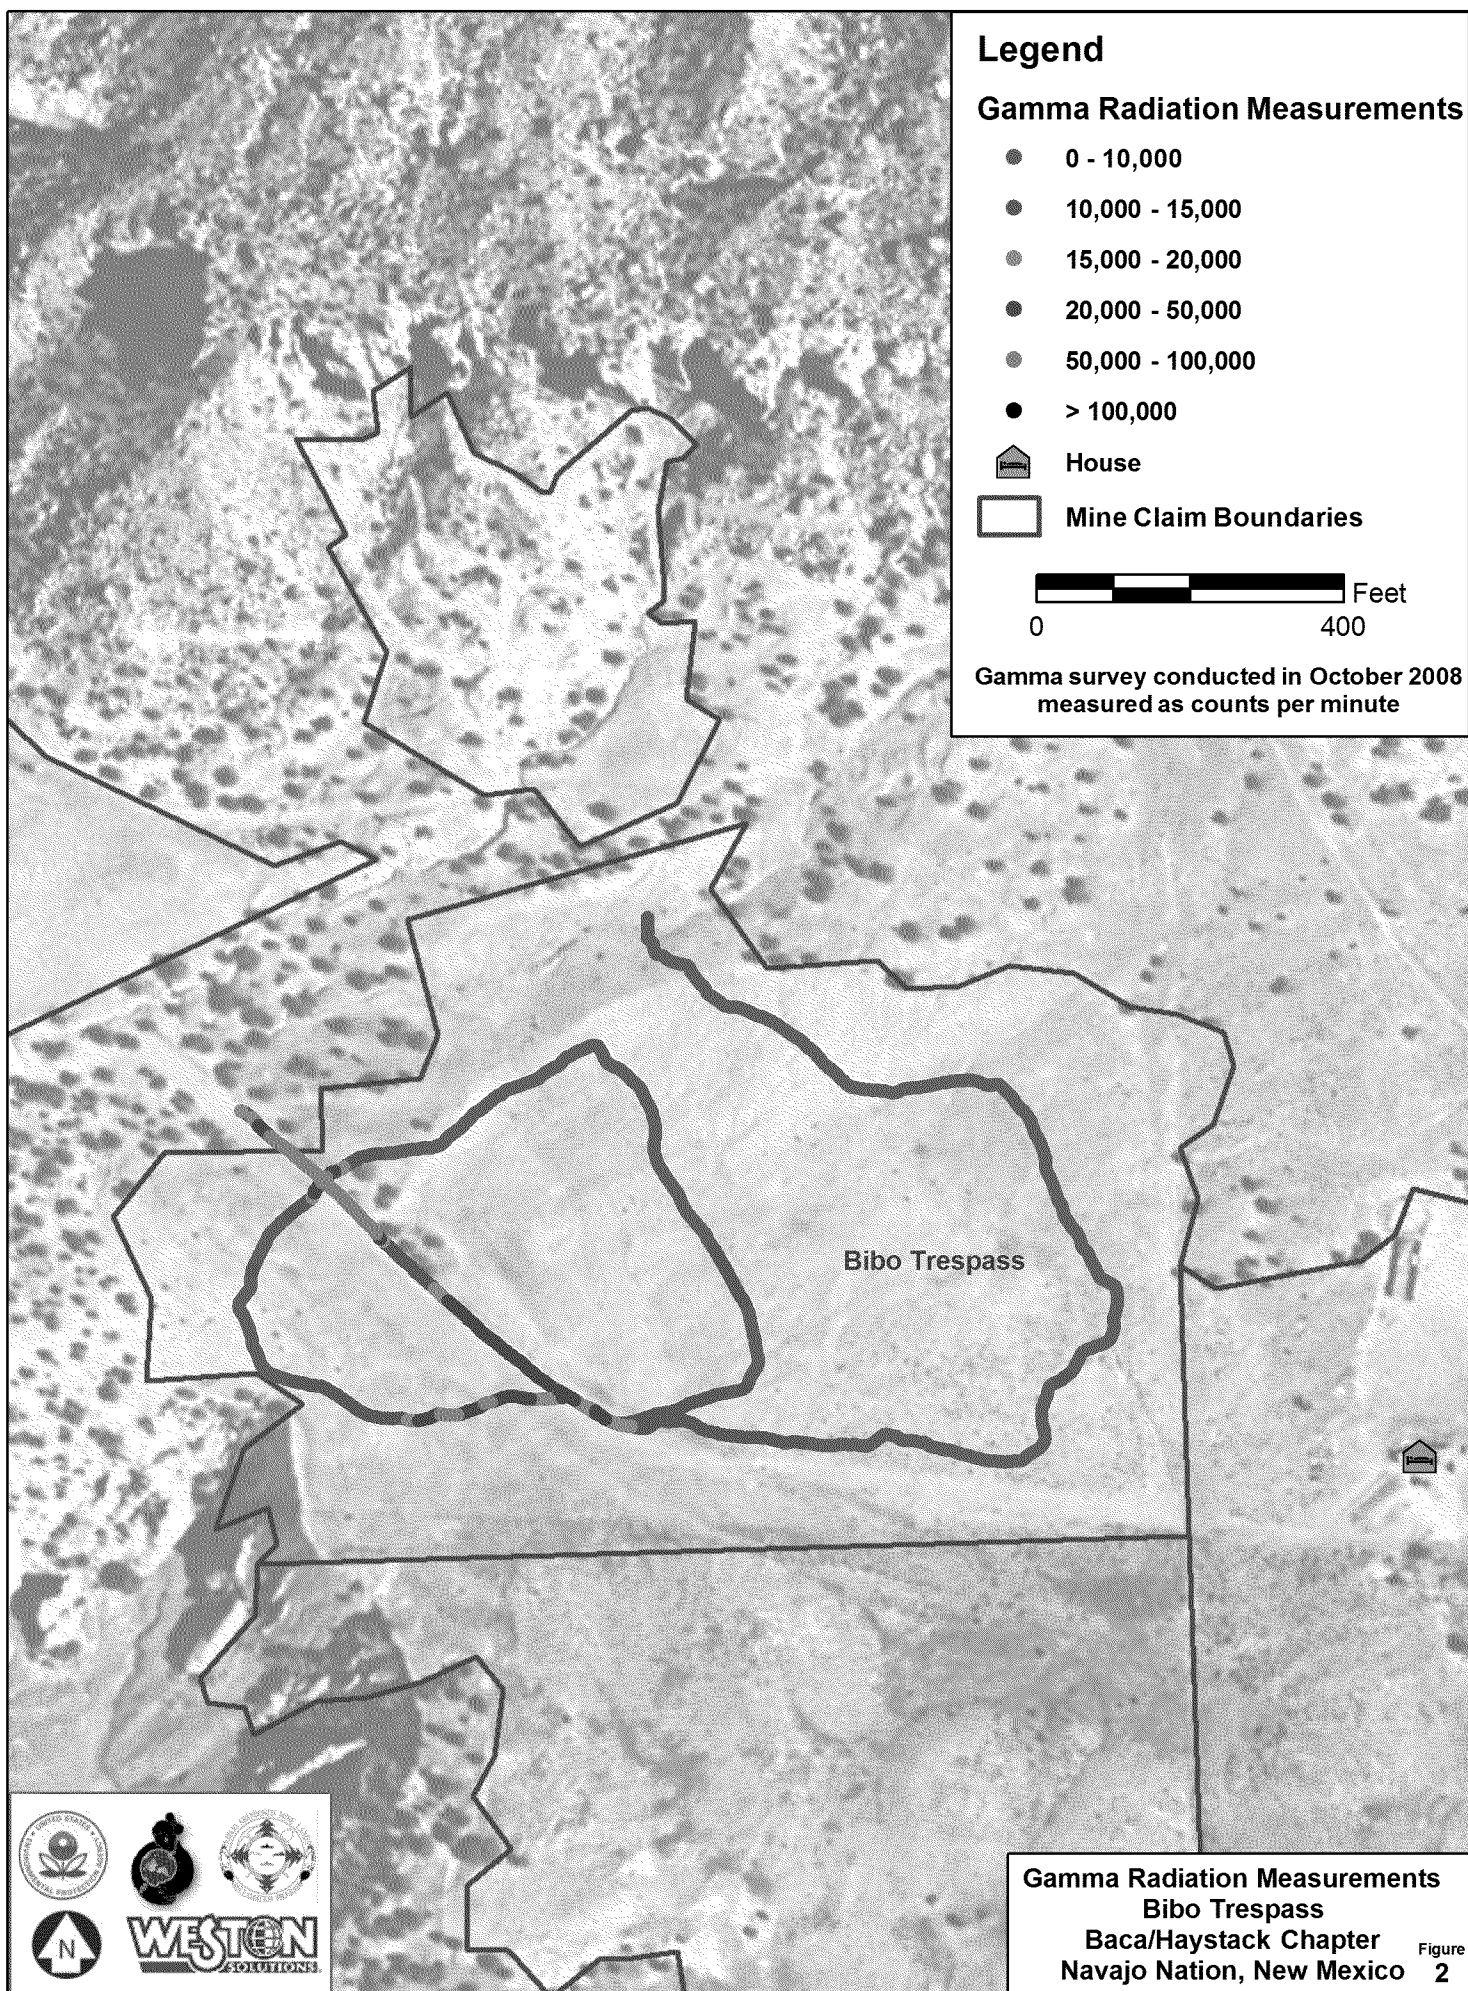
1,095 gamma radiation measurements were collected from mine sites, ranging from 6,552 cpm to 89,750 cpm. Measurements were found at their highest along the dirt road transecting the site. The measurements are represented in Figures 1 and 2.
